Microelectronics Reliability

Role of stress voltage on structural degradation of GaN high-electron-mobility transistors

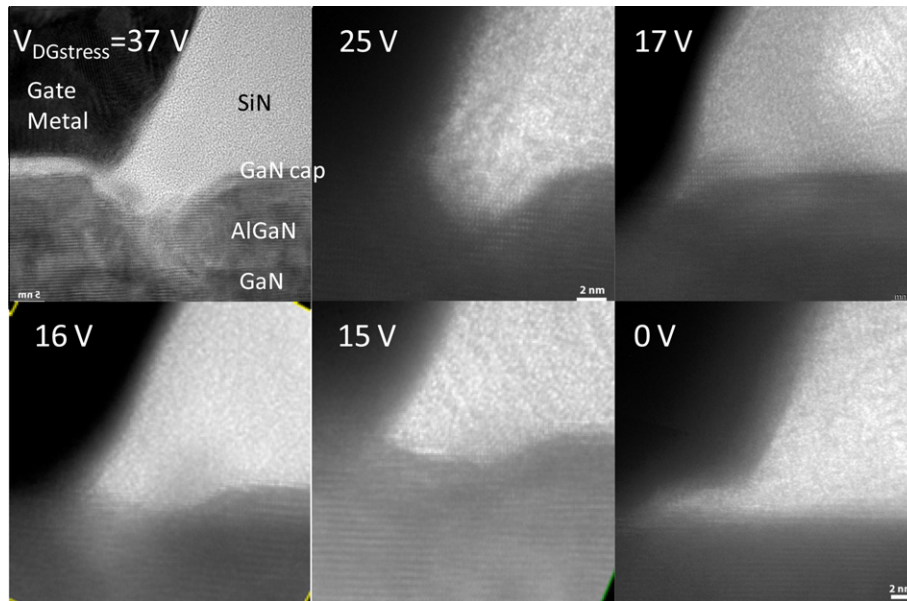
Fig. 4. Cross-sectional TEM images of the drain side of devices stressed at different voltages (device #1–6).

Fig. 4 shows TEM pictures obtained for selected devices from the step-stress experiments of Fig. 1. Near the gate edge, the control unstressed device (#6, labeled 0 V in Fig. 4) shows a smooth semiconductor surface. The devices stressed up to 16 V show minimal structural degradation. Only a small indentation less than 2 nm deep and 10 nm wide is observed on the GaN cap surface next to the gate edge. This seems to correspond to the groove that has been observed in a separate plan-view study [17]. For that reason, we will refer to this feature as a groove although TEM cannot confirm whether this feature is continuous in and out of the cross section. Devices that are stressed well beyond V_{crit} (25 and 37 V) show significant physical degradation in the form of deep pits (up to 4–6 nm in depth and 17 nm in width at the surface). For these devices, the pits penetrate into the AlGaIn barrier layer. The device stressed at 37 V also exhibits a crack-like feature that extends at an angle from the bottom of the pit to the AlGaIn/GaN interface. Since these devices are symmetrically stressed in both

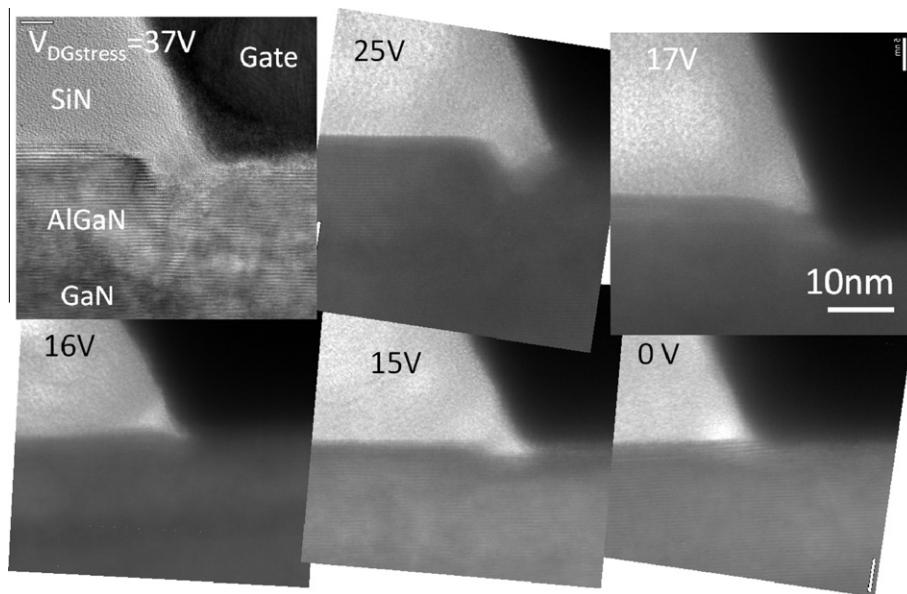
Fig. 5. TEM images of the source side of device #1–6.

the source and drain sides, similar observations were made on the source side (Fig. 5). These pictures reveal that short-term stress is enough to produce significant structural degradation if the stress voltage is higher than the critical voltage. It does also reveal the presence of small surface indentations for voltages below the critical voltage consistent with the grooves observed in [17].

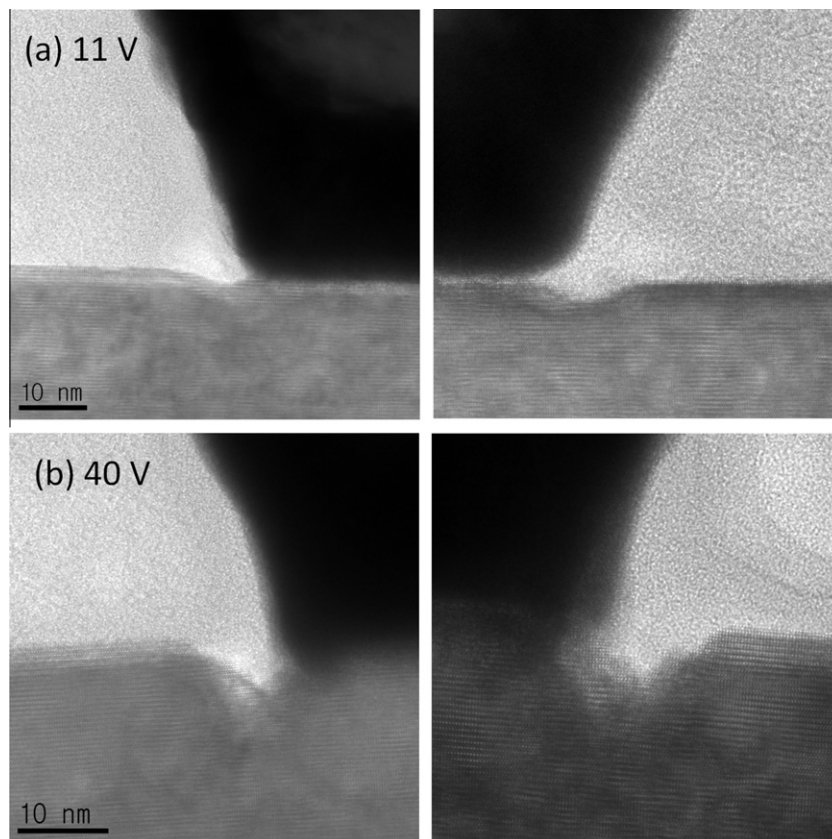
TEM images for long-term stressed devices are shown in Fig. 6. The device stressed below V_{crit} (Fig. 6a) shows a shallow groove of about 1.5 nm in depth and 6 nm in width at the gate corner. However, in spite of the extended stress time, this is again not deep enough to penetrate into the AlGaIn barrier. This small structural degradation may account for the small permanent degradation in I_{Dmax} . The sample stressed beyond V_{crit} for a long time (Fig. 6b) shows a deeper (~6 nm) pit that reaches into the AlGaIn layer. This result suggests that stress at voltages in excess of V_{crit} is necessary for deep pit formation.

Fig. 6. Cross-sectional TEM images for long-term stressed devices. The source (left) and drain (right) sides are shown. Stress voltages are: (a) $V_{\text{DG}} = 11$ V (device #7) and (b) $V_{\text{DG}} = 40$ V (device #8).

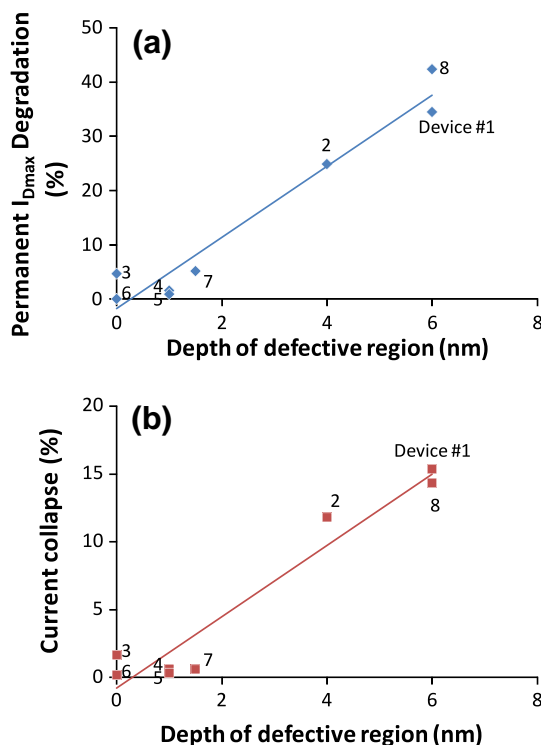
To provide a quantitative comparison between electrical and physical damage, we have measured the width and the depth of the pits that are observed in TEM pictures. We have then graphed the degradation in uncollapsed I_{Dmax} (in absolute amount) and the value of current collapse against the depth of the defective region. This is shown in Fig. 7. The permanent degradation in I_{Dmax} and the current collapse both correlate well with the depth of the defective region. Serious electrical degradation only takes place when the depth of the defective region exceeds the GaN cap thickness (~ 3 nm). It is noted that the long-term stressed devices (#7 and 8) also fall in the same correlation as the short-term stressed devices (#1–5).

Fig. 7. Correlation between electrical and structural degradation for all samples in this study: (a) permanent I_{Dmax} degradation vs. pit depth and (b) current collapse after stress vs. pit depth.

The correlation between electrical degradation, as measured through I_{Dmax} , R_S and R_D , and structural degradation, as evaluated through the depth of the defective region observed in cross-section TEM, is entirely consistent with a similar study that utilized AFM and SEM mapping of the semiconductor surface after gate and dielectric removal [17]. This is true in spite of the fact that, in the present study, a single cut was made at a random location across the width of the device. It is not surprising that the prominent defects observed here and in [17] result in permanent (non transient) degradation of the drain current. The formation of deep pits should induce local strain relaxation which ought to result in a local reduction of piezoelectric-effect induced charge, and a decrease in the sheet carrier density. With stress in the $V_{DS} = 0$ re-
